# Friction, Roughness and Boundary Layer Characteristics of Freshwater Biofilms in Hydraulic Conduits

Submitted in fulfilment of the requirements for the Degree of  
Doctor of Philosophy, University of Tasmania, December 2006

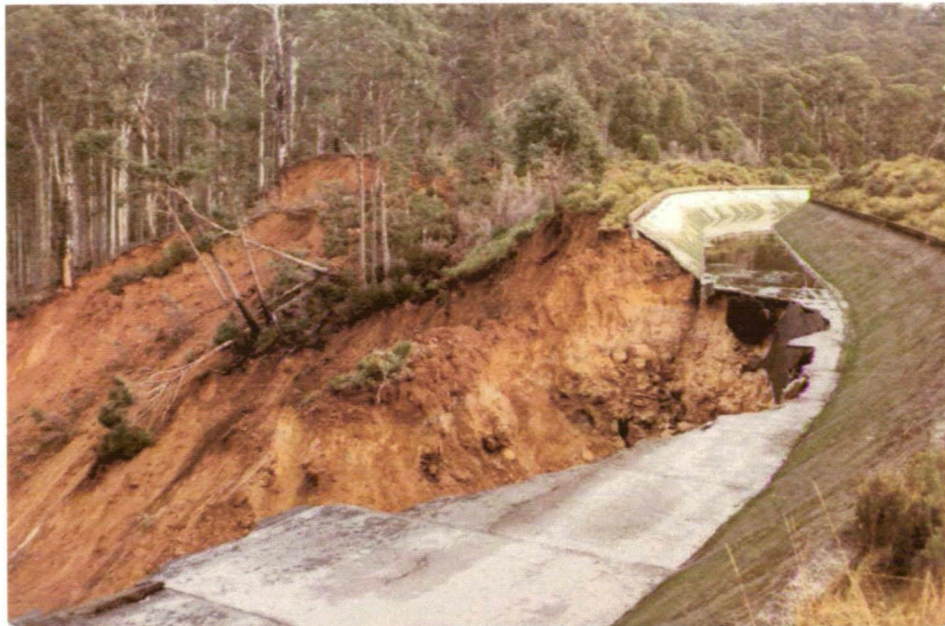
Figure 1.2: Failure of a canal due to overtopping and subsequent erosion of soil. Significant water and economic losses occurred due to the failure and following asset outage for repair (photo courtesy Hydro Tasmania).

Biofouling also creates safety and maintenance issues. Figure 1.2 shows the devastating result of a major canal failing due to over topping. As the fouling causes a reduction in velocity in the canal, to maintain flow rates, water levels must rise.

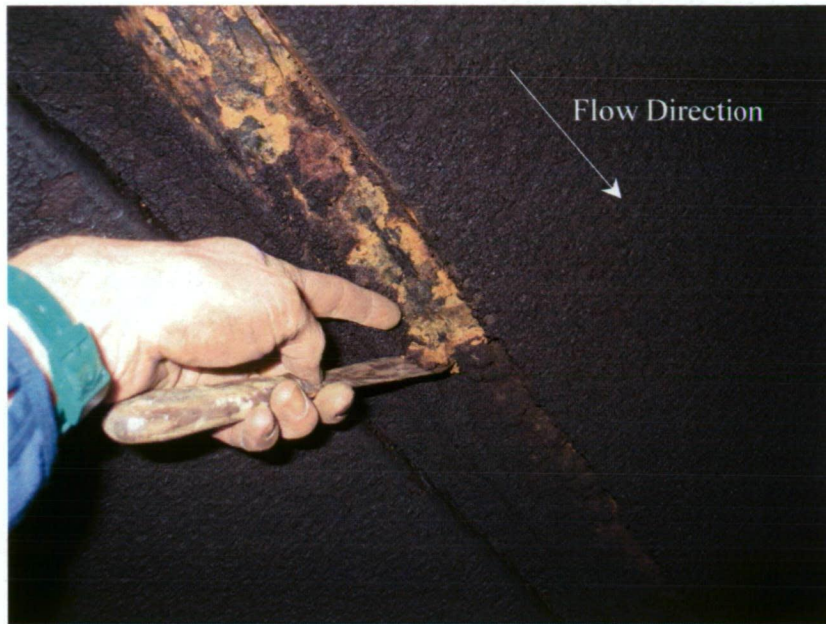
Figure 2.2: Type B biofilm showing hard deposits found inside pipelines.

Figure 2.1 shows type A fouling. Figure 2.2 shows type B fouling. Figure 2.3 shows type C fouling. This is a general classification, and any combination may be found in any conduit.

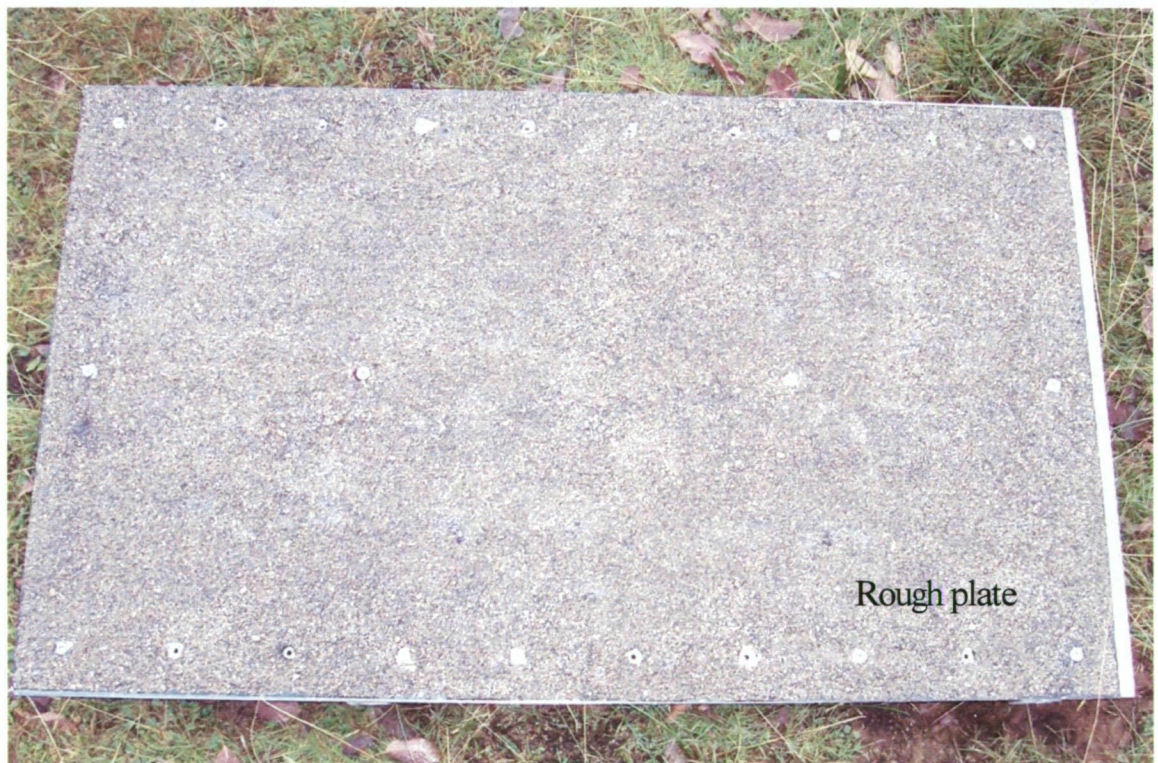
Figure 4.24: Large test plates (clean) looking from above.

There were six large plates in total, with three smooth painted plates and three fine grit rough plates. One of each type was deployed at Transition No. 4 and Pond No. 1 along with the small test plates. The remaining smooth and rough plates were kept in the laboratory as clean control plates for baseline measurements, and also photogrammetry development for baseline roughness data.

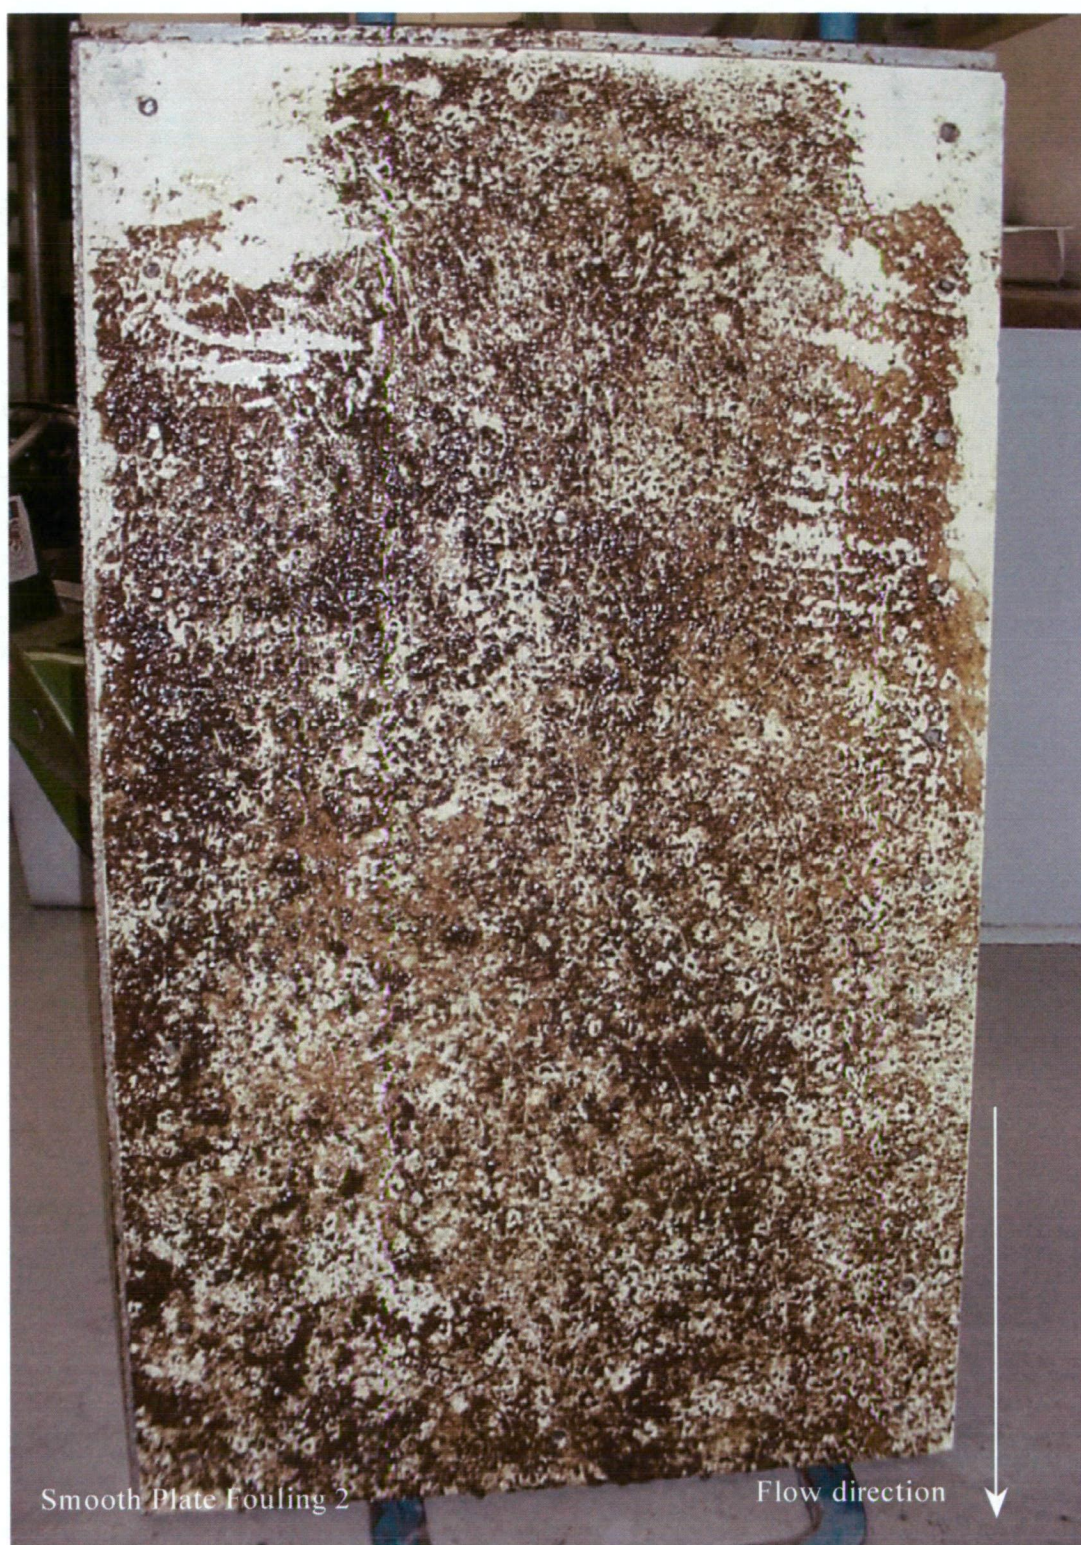
Figure 7.4: Photo of smooth plate fouling 2 prior to testing in the water tunnel.

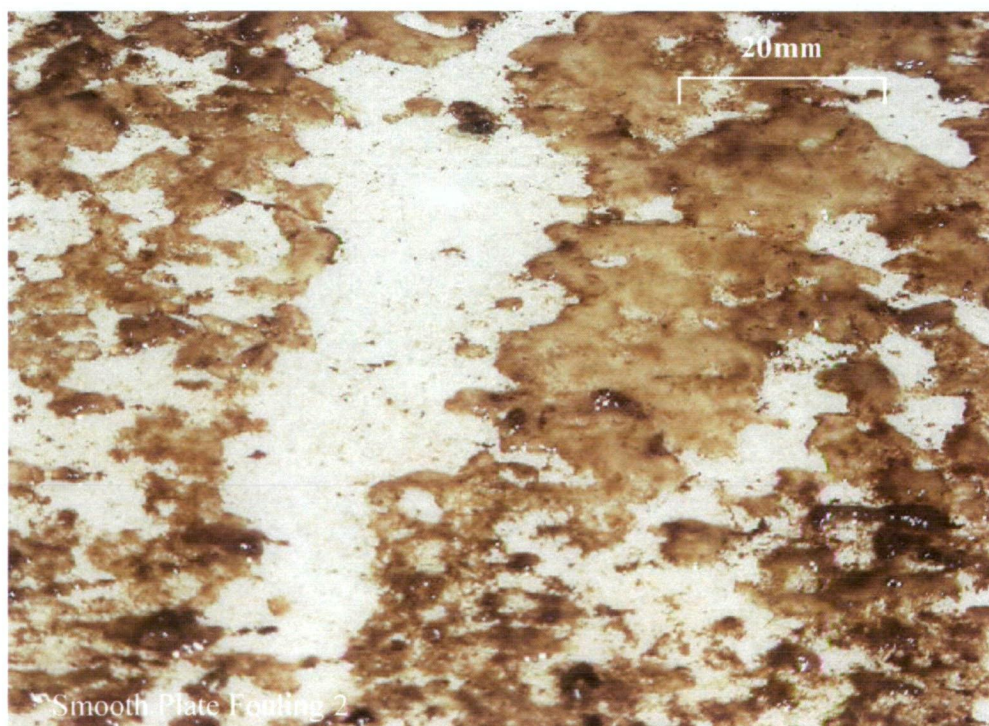
Figure 7.6: Close up of low form gelatinous growths.

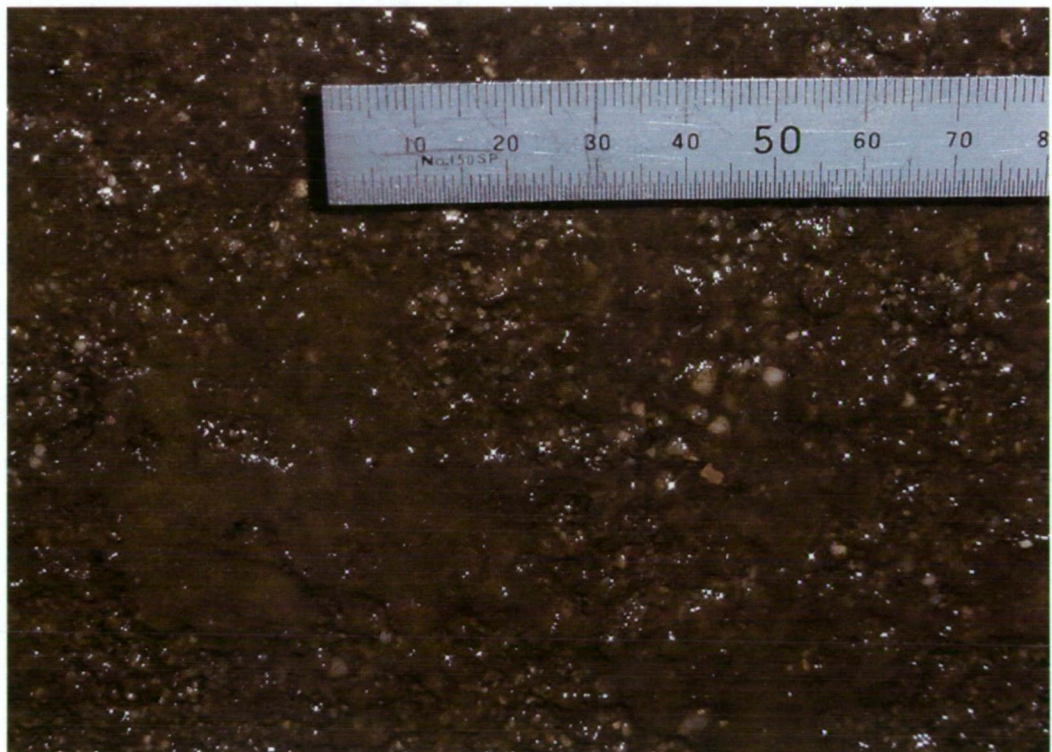
Figure 8.6: The scale of the growth for fouling 2 is shown. Many patches of biofilm approximately 30 to 50mm across are apparent across the entire plate.

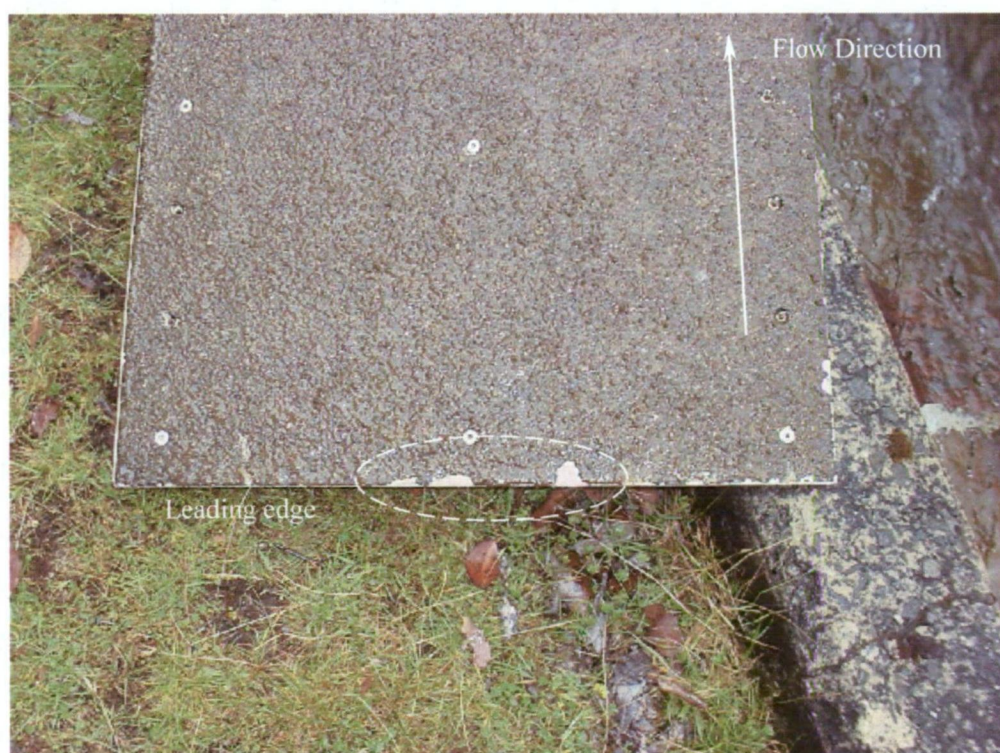
Figure 8.8 Rough plate fouling 2 ready to be re-deployed after testing. Seen at the leading edge of the plate (dashed ellipse) are missing portions of the rough surface.
